State of Nevada
Department of Administration – State Public Works Division
Buildings and Grounds Section
Marlette Lake Water System
Facility Condition Analysis

MARLETTE LAKE WATER SYSTEM

Site Number: 9788
STATE OF NEVADA PUBLIC WORKS DIVISION
FACILITY CONDITION ANALYSIS

Report distributed in May 2018

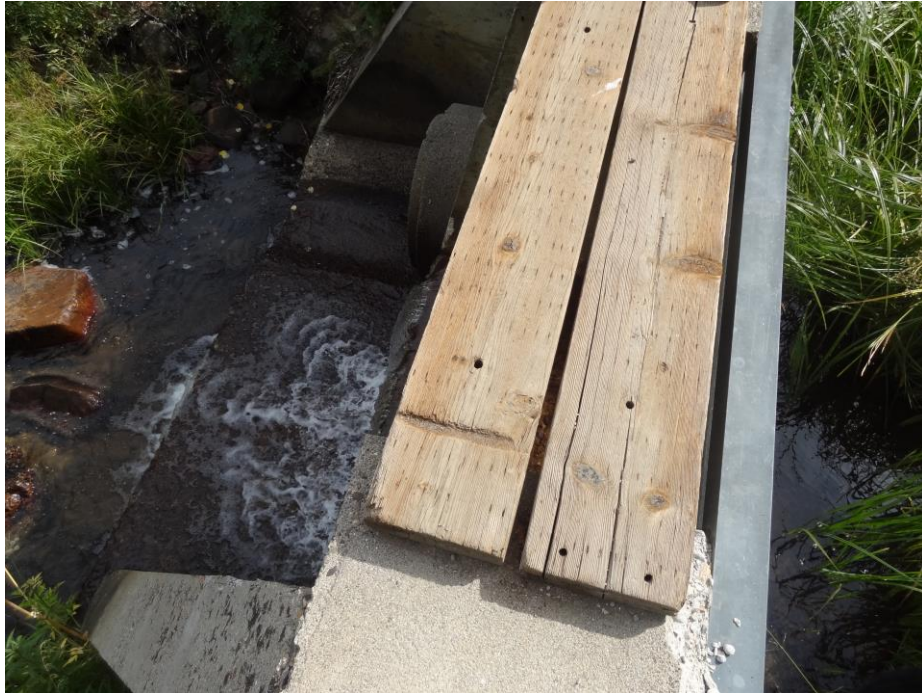
The Marlette Lake Water System Site has several dams, uneven walking surfaces and wet locations that don't have the proper slip resistant platform walking surfaces required by OSHA 1910.22(a)(2). Where wet processes are used, drainage shall be maintained and false floors, platforms, mats, or other dry standing places should be provided where practicable. There are several locations where it is required for employees to access dams, buildings and other locations where there is possible risk of falling into pits, dams and ditches. Per OSHA 1910.22(c), covers and/or guardrails shall be provided to protect personnel from the hazards of open pits, tanks, vats, ditches, etc. This project will provide funding for OSHA required nonslip platforms and railings to be installed across dams, ditches, and uneven surfacing throughout the site where necessary.

Marlette Lake Water System - Site #9788
Description: Walking surfaces / guardrails needed.

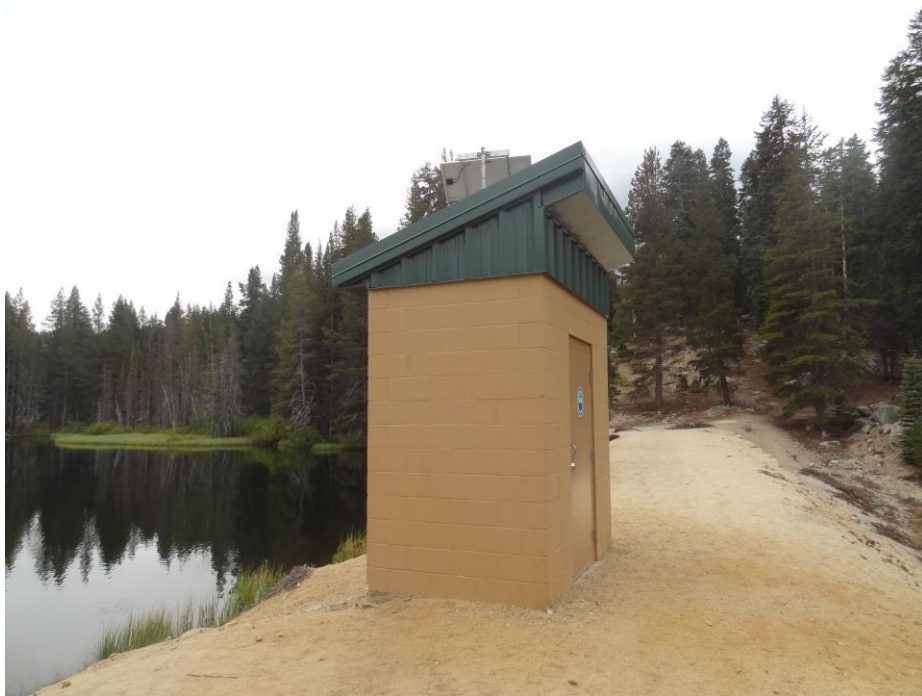
Hobart Meter Building - Building #3765
Description: Exterior landing installation needed.

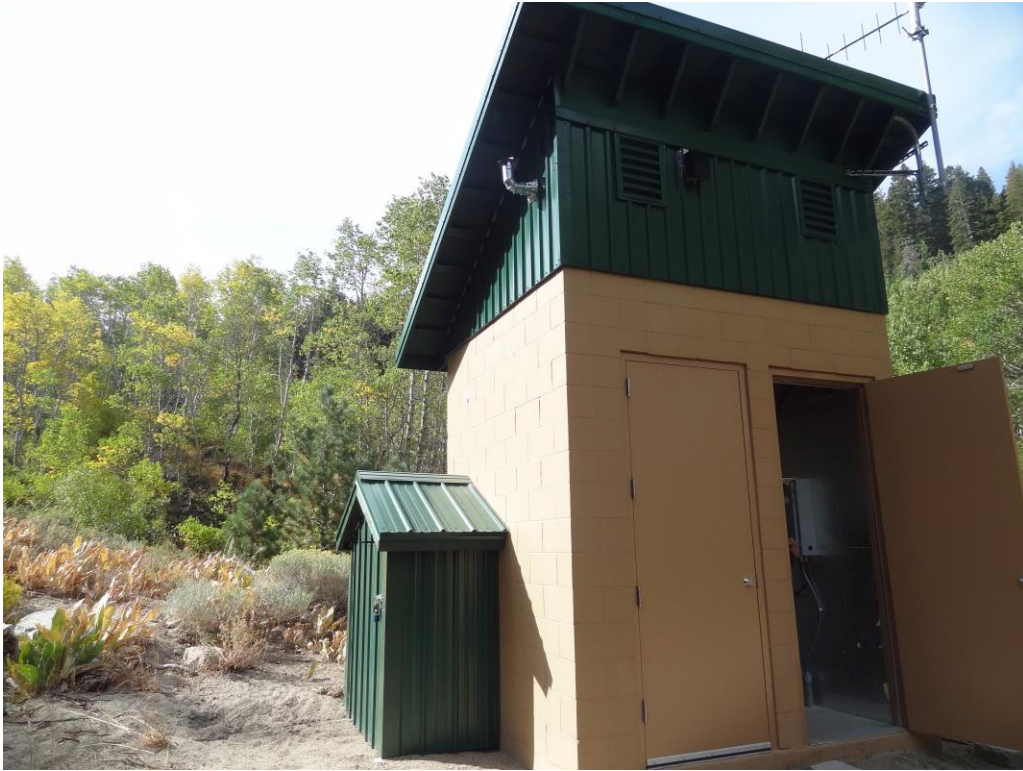
Diversion Dam Meter Building – Building #3763
Description: View of exterior finishes.

It is important to maintain the finish, weather resistance and appearance of the building. This project would provide funding to protect the exterior of the building excluding the roof. Included in the cost is painting the concrete masonry unit walls and caulking of the flashing, fixtures and all other penetrations. It is recommended that the building be painted and caulked in the next 4-5 years and that this project be scheduled on a cyclical basis to maintain the integrity of the structure.

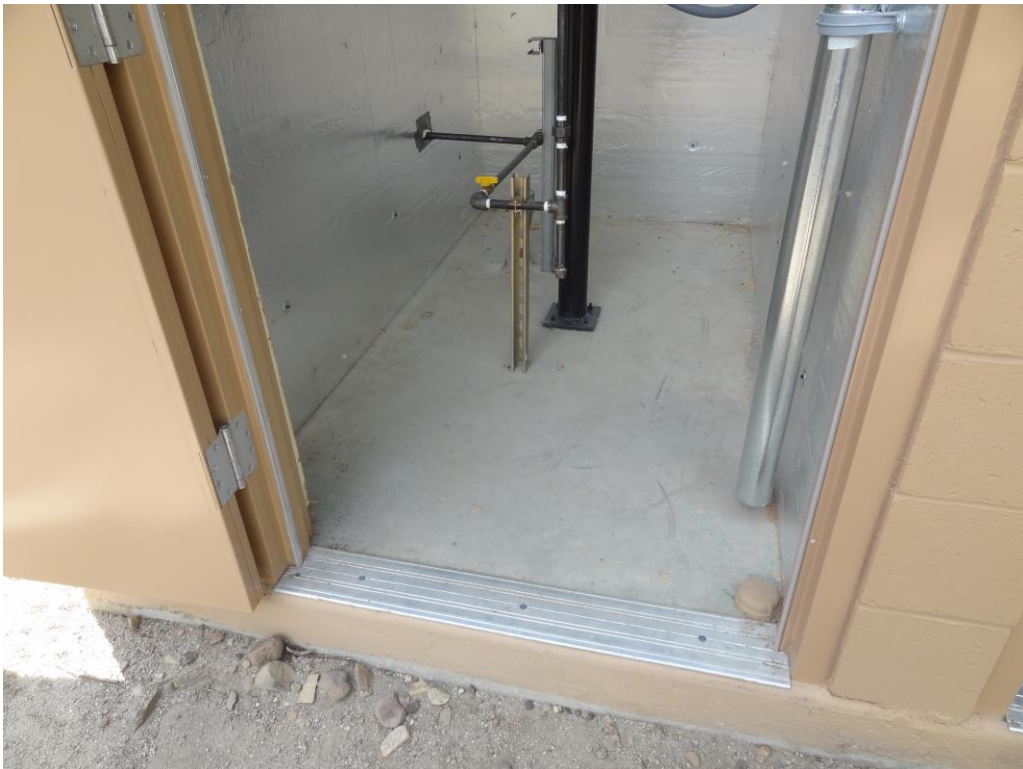
There is an out-swinging exterior door from the building that swings out over a step and does not have a landing that complies with IBC 2012. IBC Section 1008 which requires a landing to be not more than 1/2" below the threshold. This project would provide for the installation of a compliant landing for the door.

Diversion Dam Meter Building – Building #3763
Description: Exterior landing installation needed.

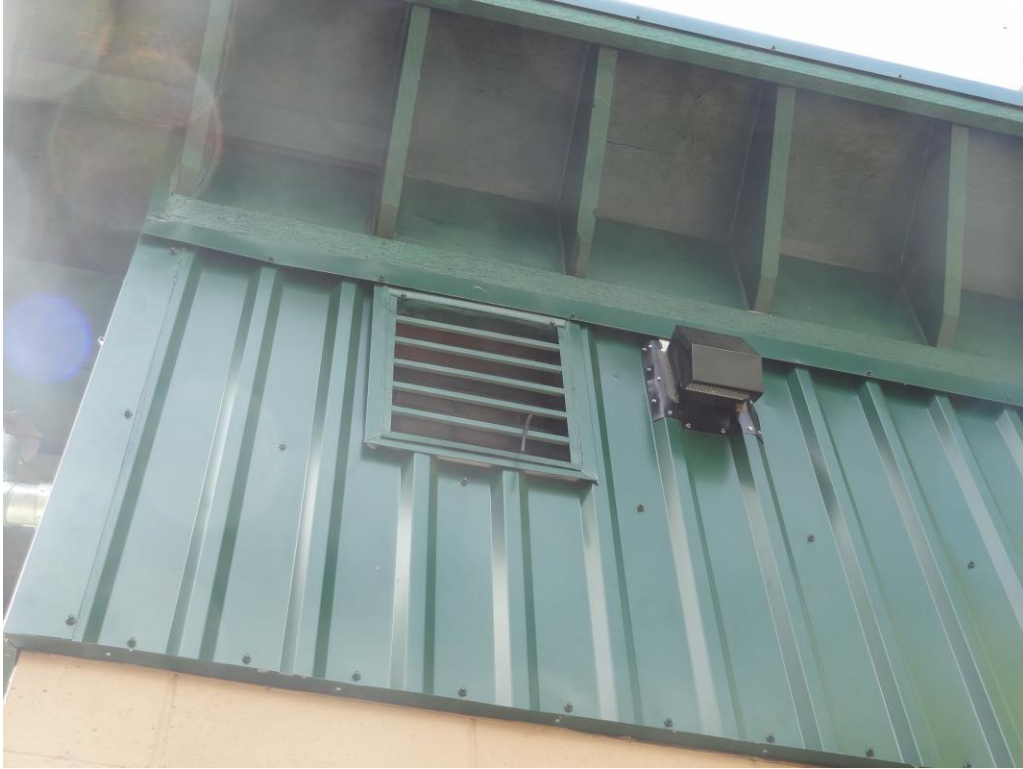
Diversion Dam Meter Building – Building #3763
Description: Flue replacement needed.

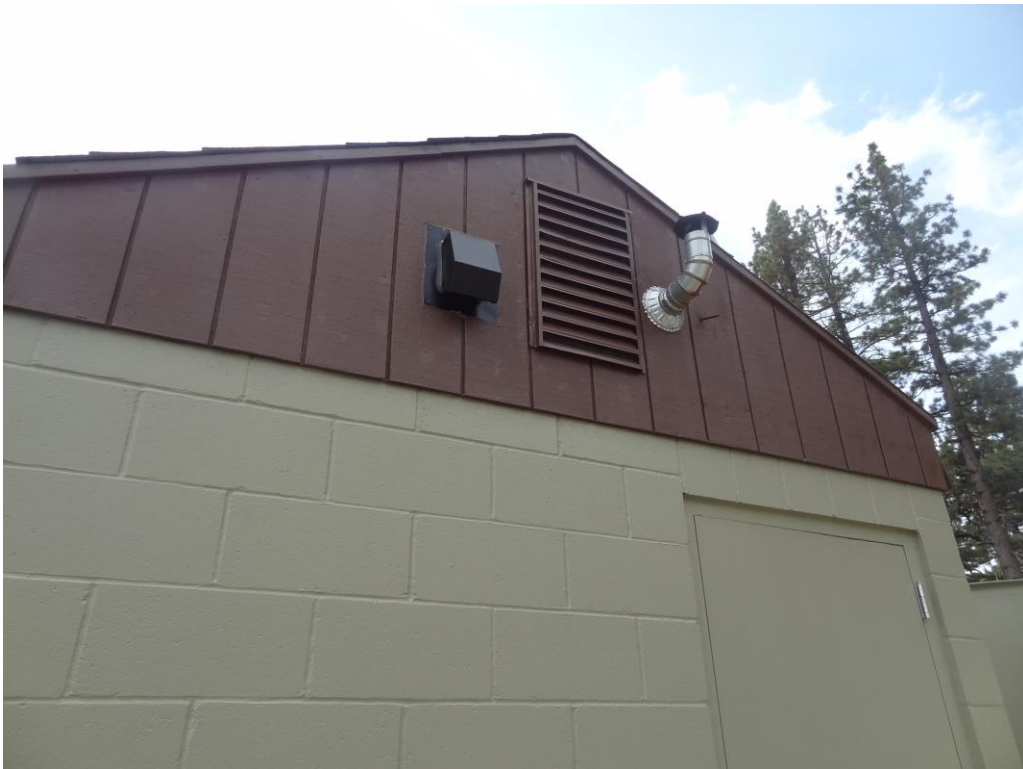
Lakeview Meter Building - Building #3761
Description: Flue distance and repairs needed.

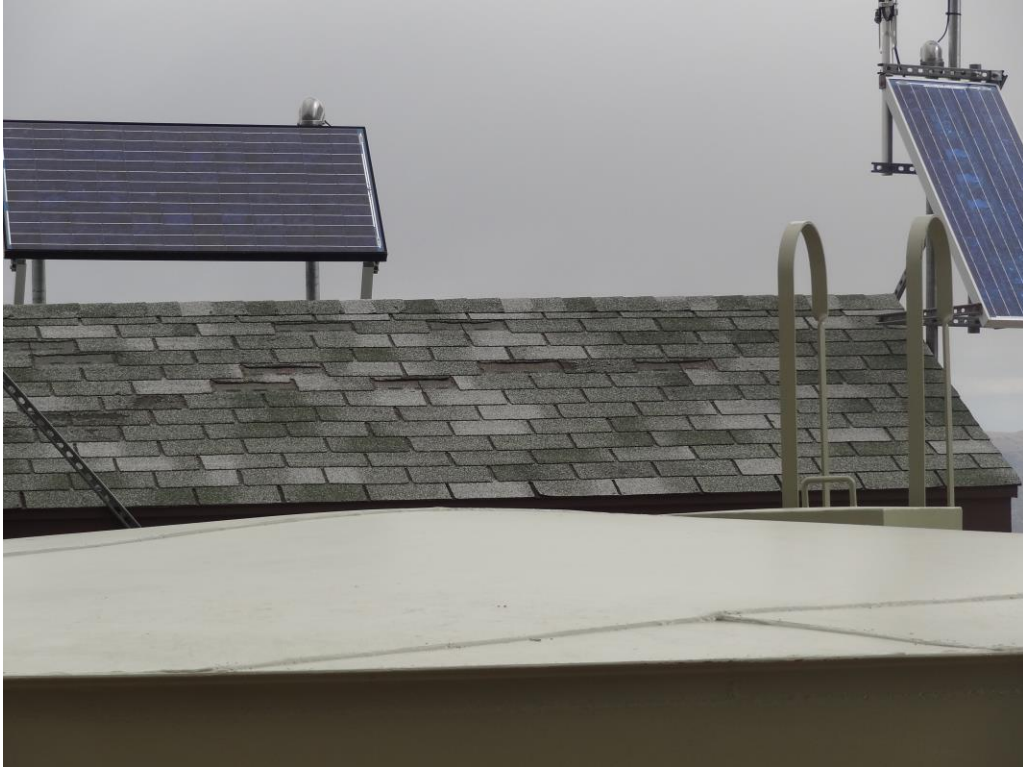
The asphalt composition shingle roof on this building was in poor condition at the time of the survey. It is recommended that this building be re-roofed in the next 1-2 years with a new 50 year asphalt composition shingle roof and new underlayment. This estimate includes removal and disposal of the old roof.

Lakeview Meter Building - Building #3761
Description: Roof replacement needed.

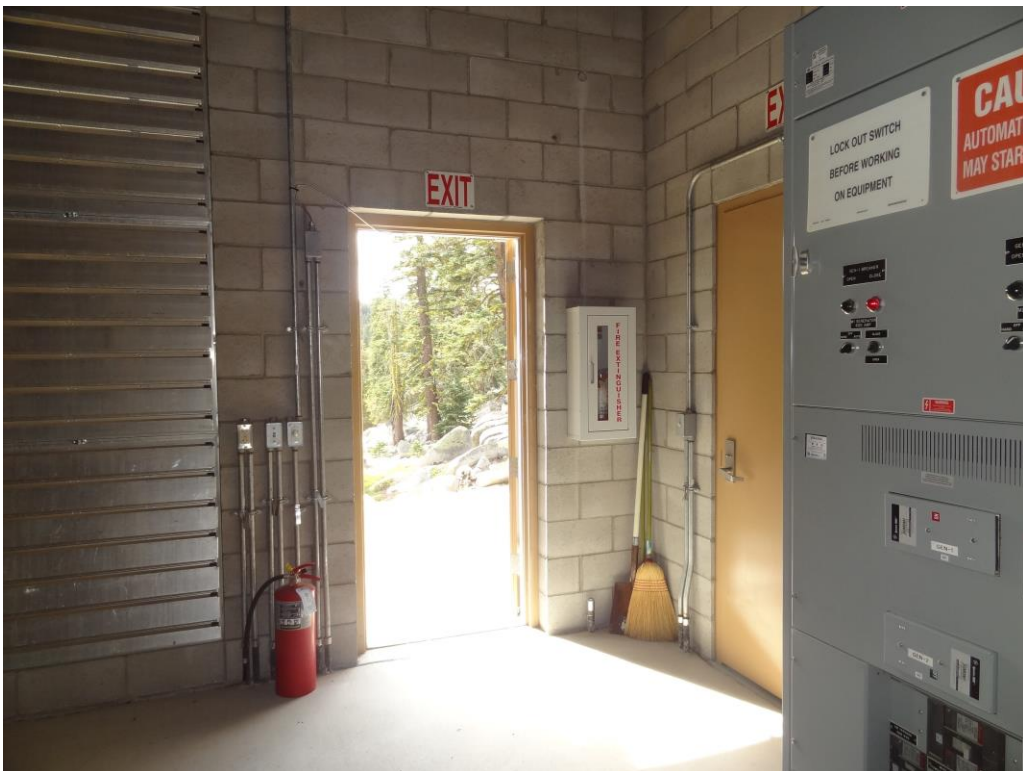
The building does not have emergency lighting and the exit signs do not meet current standards. This project would provide for the purchase and installation of self-illuminated or LED style exit signs with battery-backed internal systems as well as emergency egress lighting to provide illumination along the egress route. IBC 2012 Chapter 10 was referenced for this project.

Generator Building - Building #3031
Description: Exit sign and egress lighting needed.

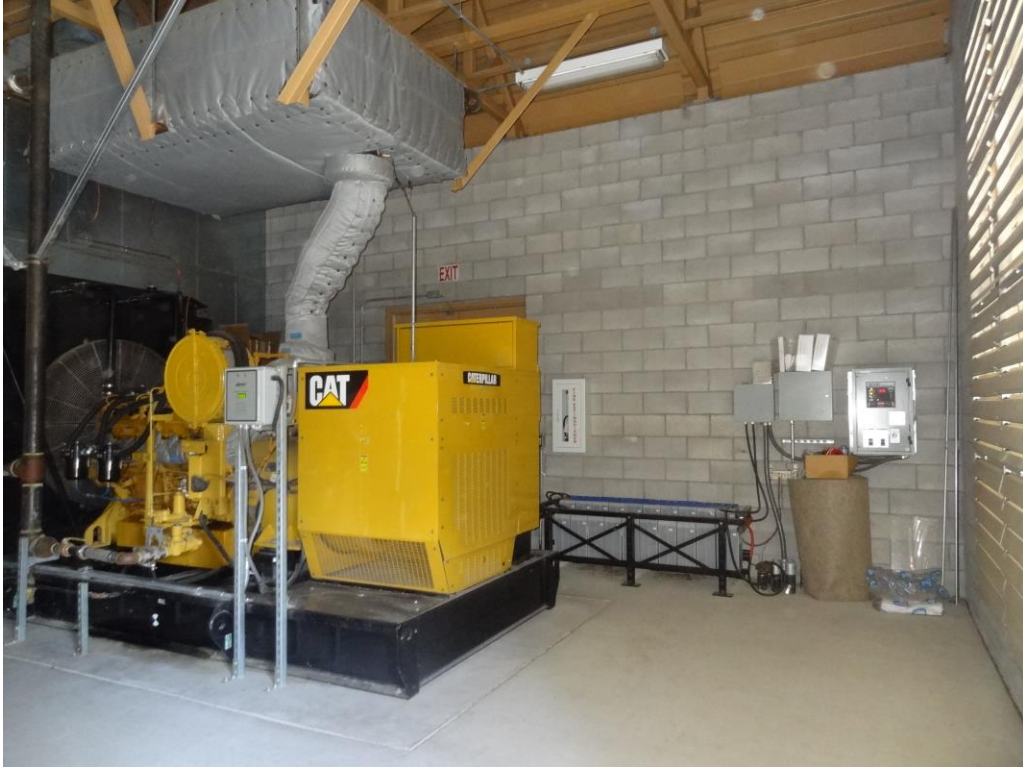
Preventative maintenance for generators plays a critical role in maximizing reliability, minimizing repairs, reducing long term costs and prolonging the life expectancy of generators. This project would provide for a licensed contractor to perform the preventive maintenance on the generator that is required from the manufacturer specifications.

Generator Building - Building #3031
Description: Generator maintenance needed.

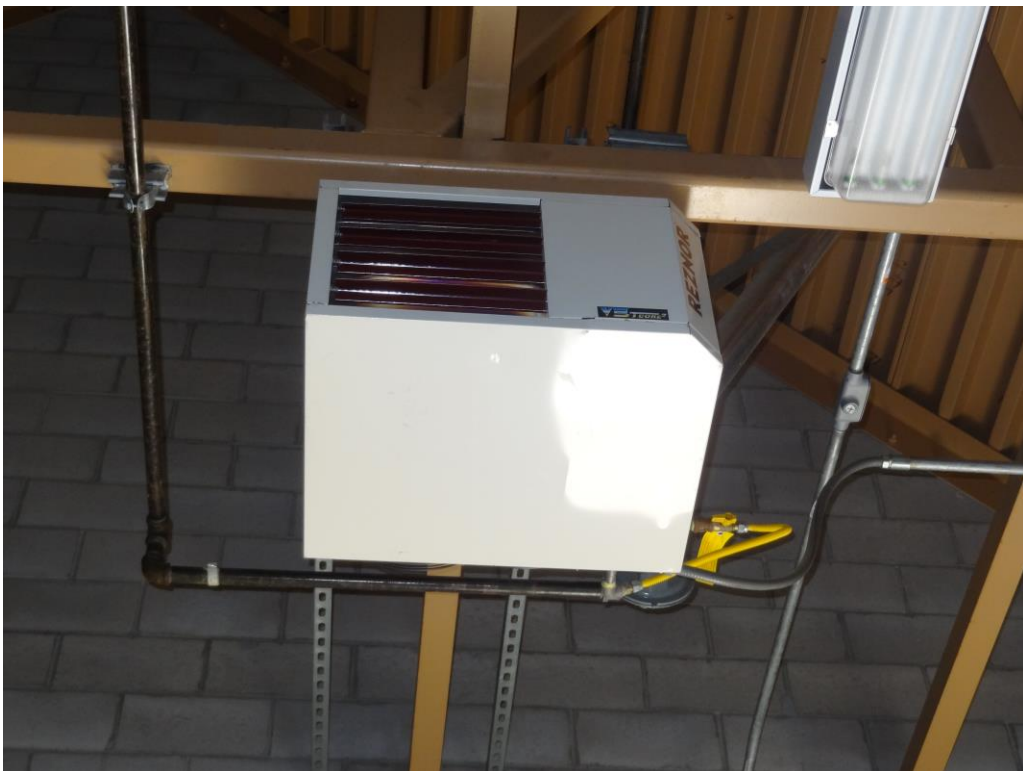
The building currently has open combustion air for the generator. The combustion air is located on the side wall and on the ceiling. When the heater runs in the building the heat rises and escapes through the combustion air on the ceiling. This makes the building very unpleasant to work in when the weather is cold. This project would remove the existing heater and provide for the installation of two suspended radiant heaters. The estimate includes two radiant heaters, seismic supports and connections to all the utilities.

Generator Building - Building #3031
Description: Heater replacement needed.
